**DEVELOPMENT CONTROL AND REGULATORY BOARD**

**LEICESTERSHIRE COUNTY COUNCIL**  
**BIRSTALL (PARK ROAD) NO. 2 TREE PRESERVATION**  
**ORDER 1964**

**REPORT OF THE DIRECTOR OF ENVIRONMENT AND TRANSPORT**

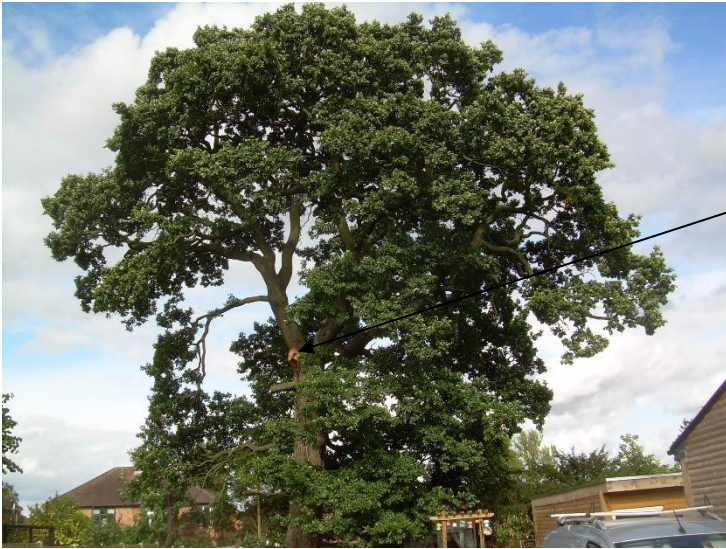
10. The oak tree T1 formed part of the 19<sup>th</sup> century parkland around Goscote Hall that was developed in the 20<sup>th</sup> century as a residential housing estate. The tree is in the Applicants rear garden 58.0m from Park Road and 50.0m from Walker Road. It has a stem diameter of 120cm and a height of 22.0m. The main stem splits at 7.0m in to 4 major structural branches that form a crown of over 15.0m in width. There are break out wounds on the main stem and the 4 main structural branches. The middle structural branch is 50cm in diameter has a decay cavity at 9.0m from the ground that extends 22cm in to the branch. The main branch on the east side of the stem was found to have a break out wound at 3.0m from the main stem and extends 11.0m with secondary branch growth end weighting the branch. A low large diameter branch on the north of the stem 12.0m in length grows over the rear garden of 27 Walker Road. The recent failure of the large branch of the oak T1 occurred in still weather conditions and showed signs of internal decay. The collapse of this heavy branch weakened the decayed smaller diameter branch below that failed the following day. The recent loss of the 2 branches on the west side of the tree has created a large opening in the crown that unbalances the tree. It was observed that the foliage in the crown is in good physiological condition with little dead wood.

Oak T1 viewed from 9 Park Road

20. It is recommended that Consent is granted to fell the oak T1 and plant a replacement oak tree as 8-10cm girth 2.5m high standard tree in the next planting season November 2019 to March 2020. Should the replacement tree die within 5 years from planting a replacement tree of the same species must be planted.

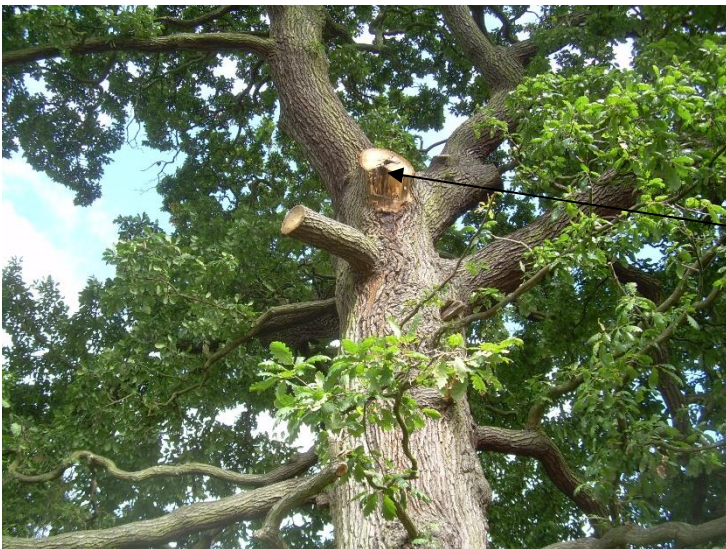
9. The Applicants wish to fell the oak tree T1 as it has over the last 6 years had large diameter branches break out and, on the 13th July 2019, a major low branch 50cm in diameter and 6.0m in length weighting up to 1.0 tonne broke out causing significant damage to a vehicle parked in the grounds of 13, Park Road and damaging 20.0m of the boundary fence. The following day a further smaller diameter branch broke out narrowly missing the Applicant who was clearing up the previous broken branch. The fallen branches were found to have significant internal decay and have left wounds that are showing signs of decay in the main stem and major structural branches. The Applicants are concerned that other large diameter branches are very likely to break out potentially causing damage to both their property and that of their neighbours and putting themselves and their neighbours at risk of injury.

14. The oak T1 has in the last 6 years experienced failure of large diameter branches with internal decay. The recent failure of 2 branches also with internal decay that has caused damage to the boundary fencing and a neighbour's parked car indicates that the tree has internal decay through-out the main structural branches. The major middle structural branch that is now fully exposed to westerly winds has at 9.0m from the ground a decay cavity of 50% of the cross section of the branch supporting 13.0m length of branch weighing over 2.0 tonnes. This branch is at high risk of failing. The 2 over extended end loaded branches on the north and east of the tree are also at risk of failure. The oak tree T1 is potentially dangerous.

Oak T1 showing recent breakout wound and broken branch stub on west side of stem

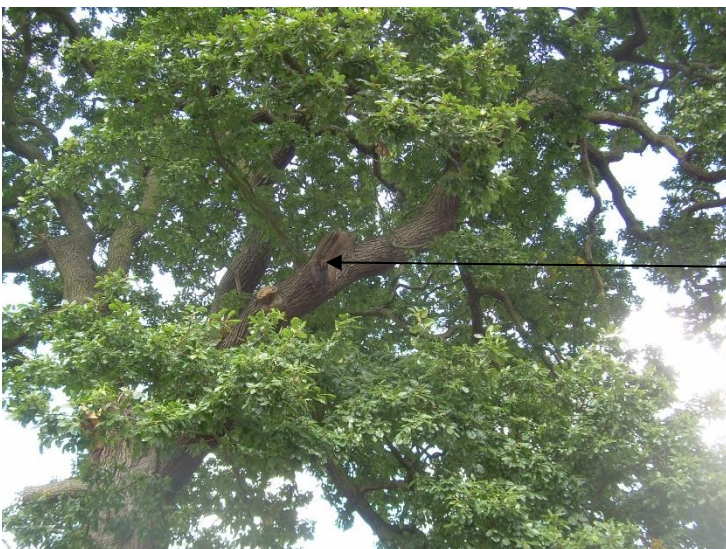
Oak T1 showing break out wounds on east branch

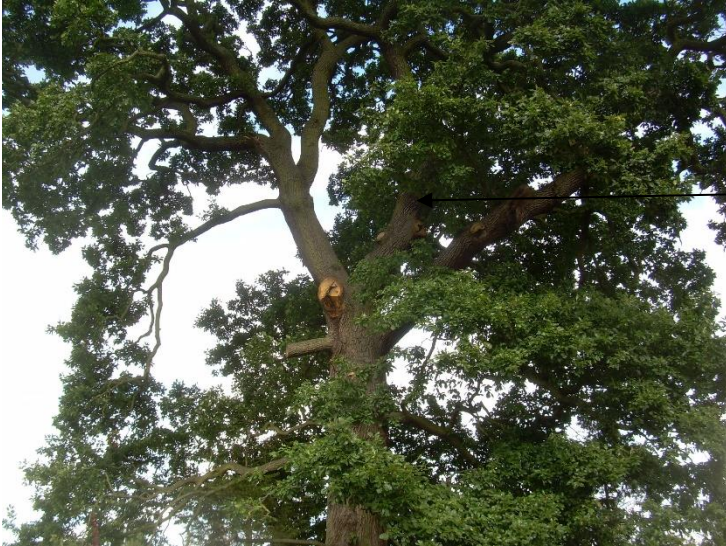
Oak T1 showing middle major branch with decay wound at 9.0m

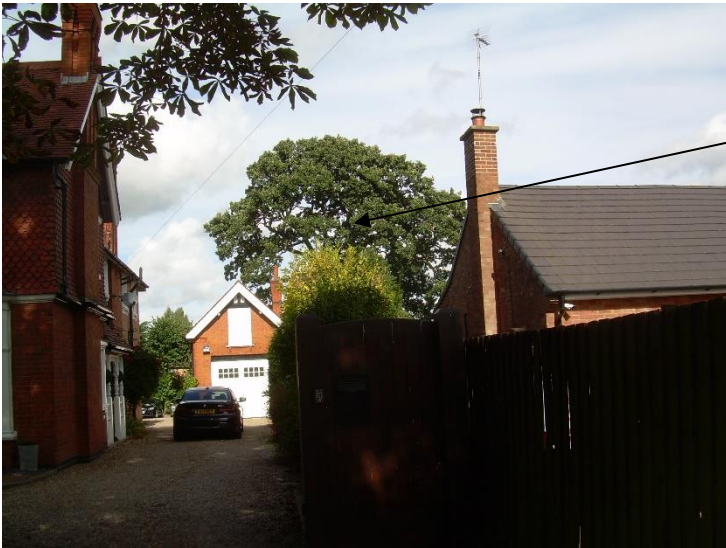
11. The oak T1 tree can be partly viewed from both Park Road and Walker Road. It has minor amenity value when viewed from the highway. The frontages of residential properties on both sides of Park Road are screened by protected large mature trees.

Oak T1 viewed from Park Road driveway of
