SURVEY OF PUBLIC ACCESS LAND (by Leicestershire Local Access Forum)

Name of site / location - Burrough Hill Country Park

Date surveys completed [24/5/2015]

Report compiled by Roy Denney & Chris Faircliffe –

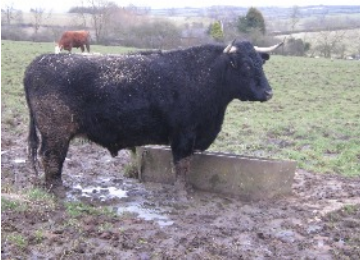
Some of the approaches are really hazardous and near impossible in wet weather.

One (D84) is through a working farmyard with beasts and a bull present on our last visit. It appears not to be a prescribed banned breed but is a daunting prospect.

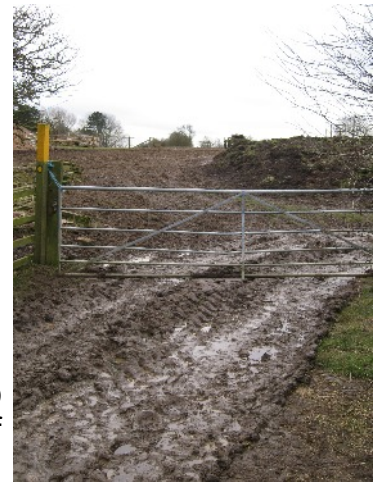
The line of this path when leaving the park is difficult to ascertain but does appear at odds with the direction of the way-marker.

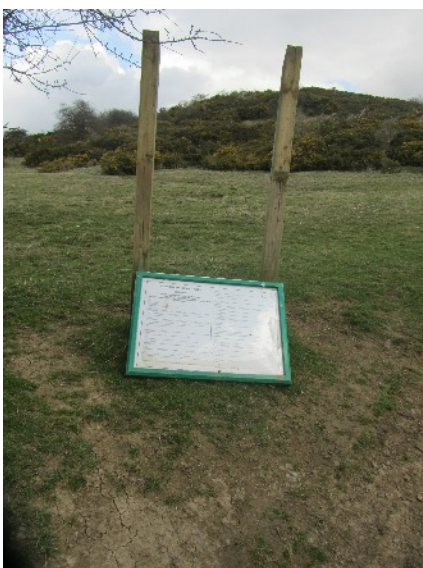
There is a board giving the byelaws where the Leicester Round enters from the north (damaged and on the ground) and another by the car park.

By the same entrance, the Open Access land sign is largely masked by a new gate support.

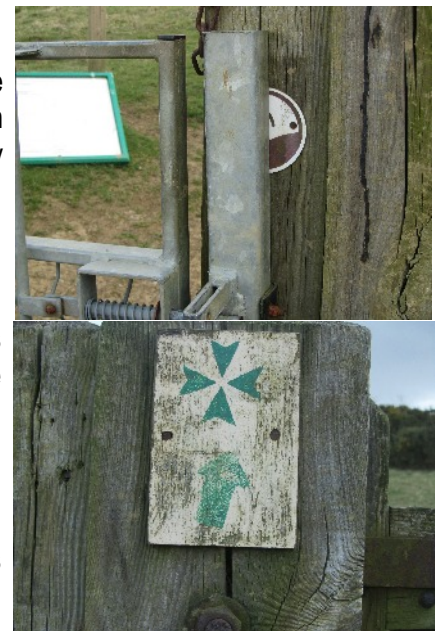
There is also an unidentified logo on this entrance.

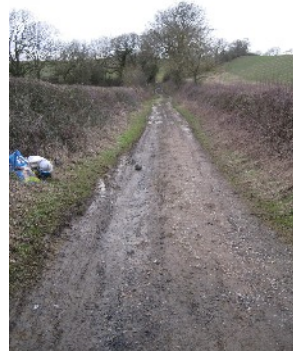
We did not spot any litter bins away from the car park nor dog waste bins anywhere nearby. Dog waste is visible on both sides of the track, from the car park to the access land.

There were piles of rubbish in a few locations within the access land and on approaching rights of way.

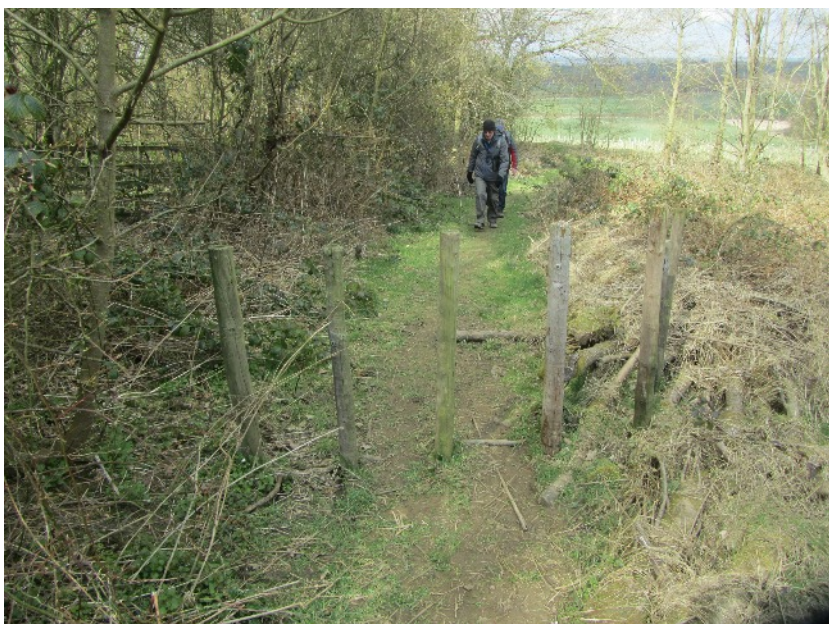
There is a BOAT leaving the country park to the north which is downright dangerous. Where it leaves the park footpath D98M splits from it and is a pleasant walk out but there is no signpost at that point to indicate it is a public footpath. The on-the-ground indication would tempt people to follow the BOAT and this is steep in places with wheel ruts cutting into the clay sometimes as much as 18 inches deep, making walking it extremely precarious.

It would also appear difficult for horses to handle and there is evidence of horse riders using the footpath to avoid it. Understandably!

The BOAT has what appear to be drainage channels cut across it which, deliberately or otherwise, prevent it being used safely. It is unsafe in poor weather conditions for people on foot or horse riders.

It may then also be necessary to consider whether the status of the BOAT needs addressing as the terrain and conditions suggest the use by motorised vehicles is not sustainable.

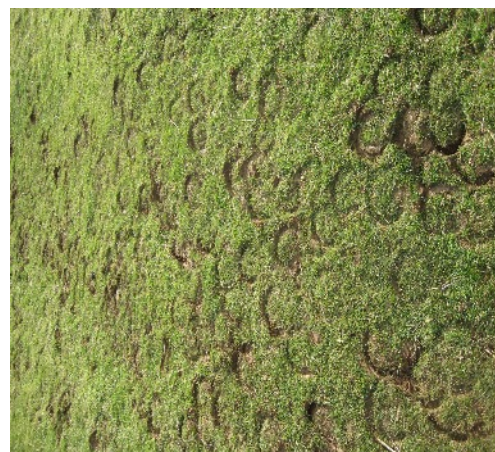
Where the BOAT meets the road there is no signage to indicate that it is a legal route never mind its status. Given the damage appears to be caused by casual motor cycle use, it may be that this is a deliberate tactic to not encourage them.

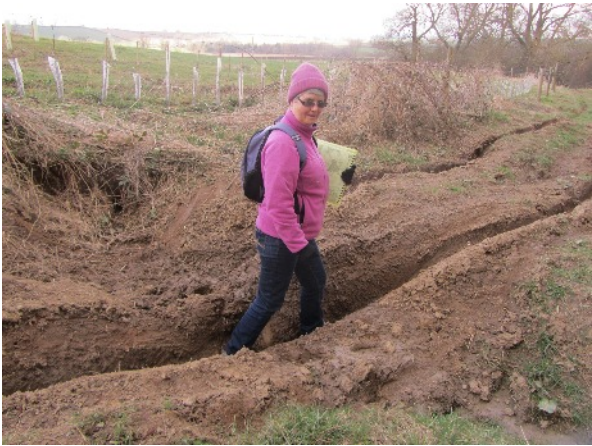
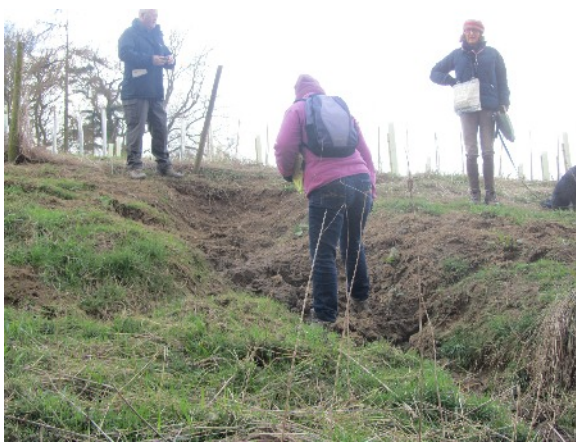
The BOAT

The stile just down the road where footpath D98M leaves the highway is in good condition and properly signposted.

Left the ruts and below where it leaves the road

Start of D98M

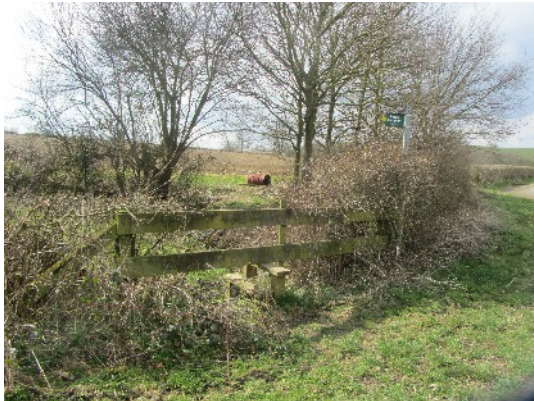
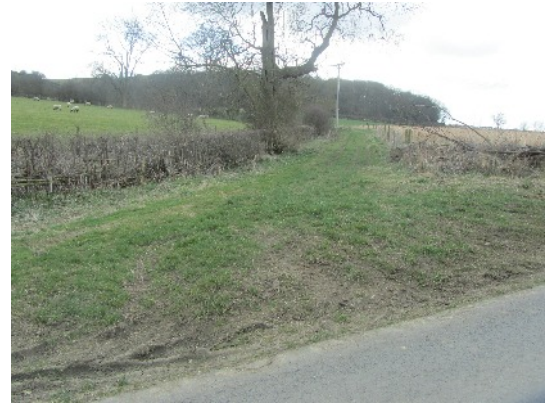
The actual line of this BOAT on the ground seems quite different from the maps.

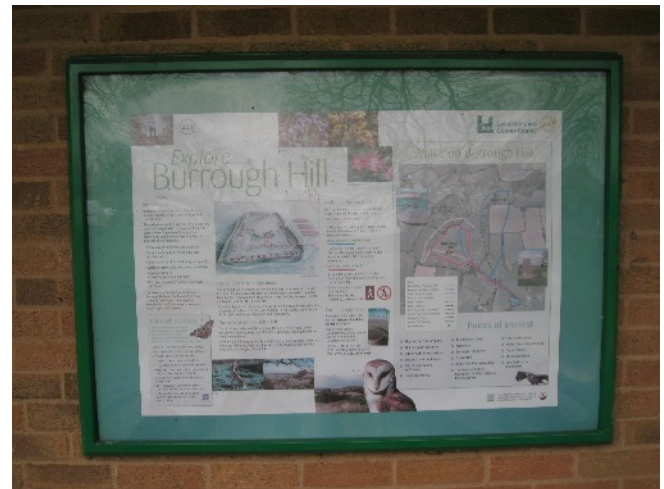
The information board at the main entrance is comprehensive and useful but does say there are signs showing when you leave the 'Open Access' area but we saw no evidence of these.

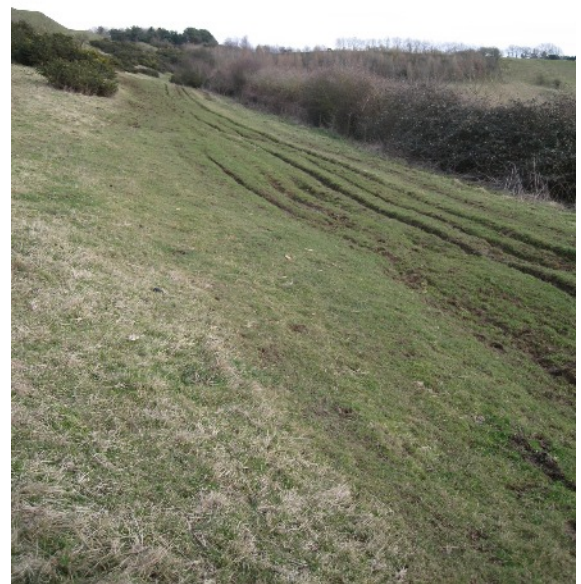
The Leicestershire Round enters the area from the north and in wet wether gets badly chopped up.

Where it passes through the Access Area it is rutted but the open aspect gives dry areas to walk along although this does mean the path is progressively widening.

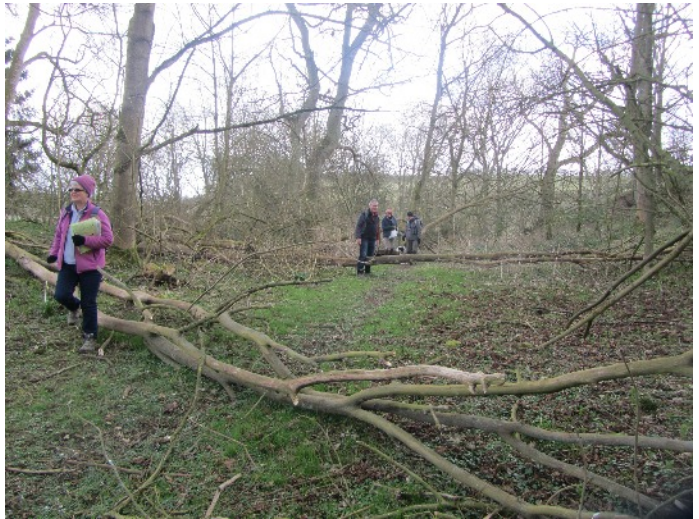
Outside the Access Land but within what we take to be the Country Park (Burrough Hill Covert), three trees are down blocking a permissive path.

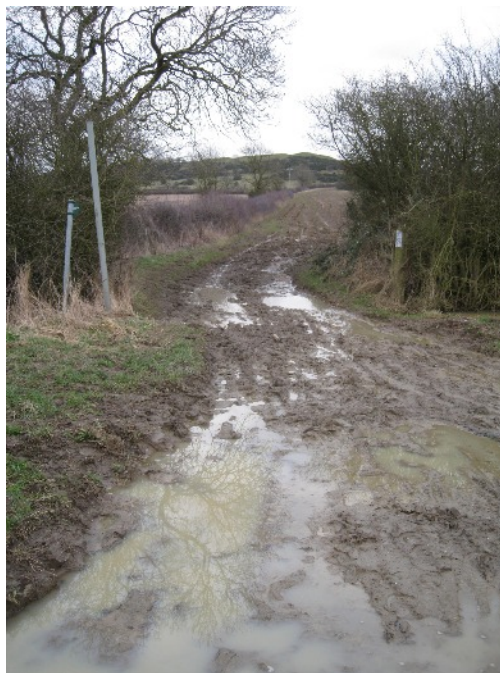
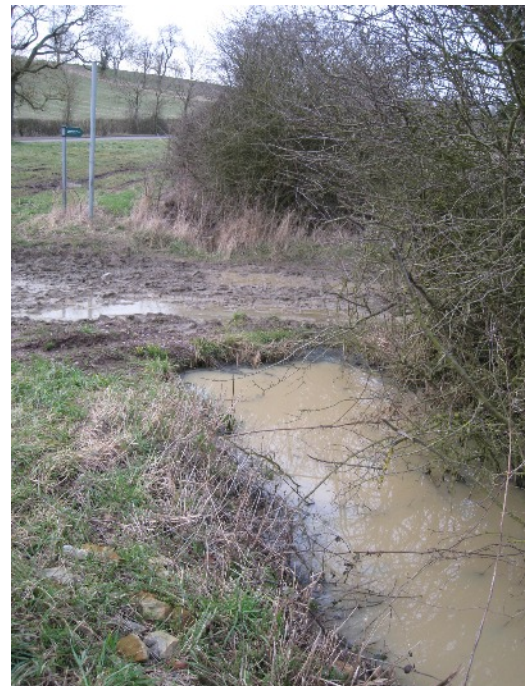
The point where the Leicester Round leaves Melton Lane heading for the park and a blocked culvert contributing to the flooding.

There is nothing can be done about the weather or the nature of the soil but some work on the worst areas is obviously needed.

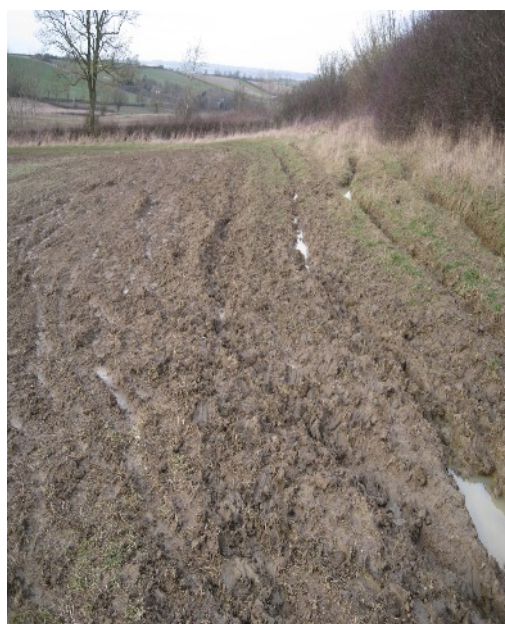
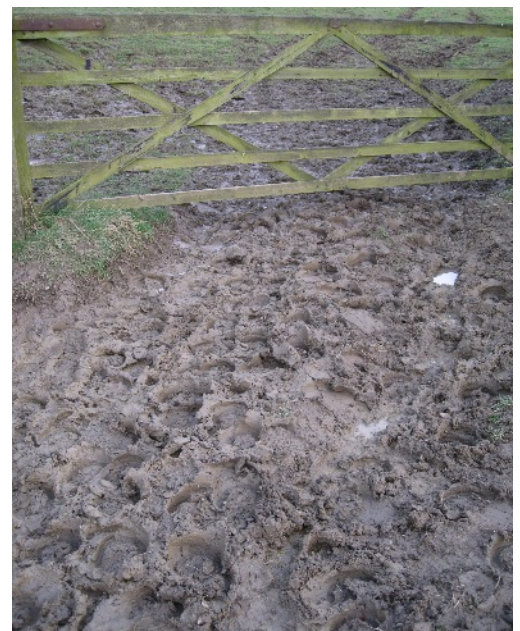
The County Road outside the site boundary leading to down to the lane and (right), more evidence of the effect of horse traffic on inappropriate surface.

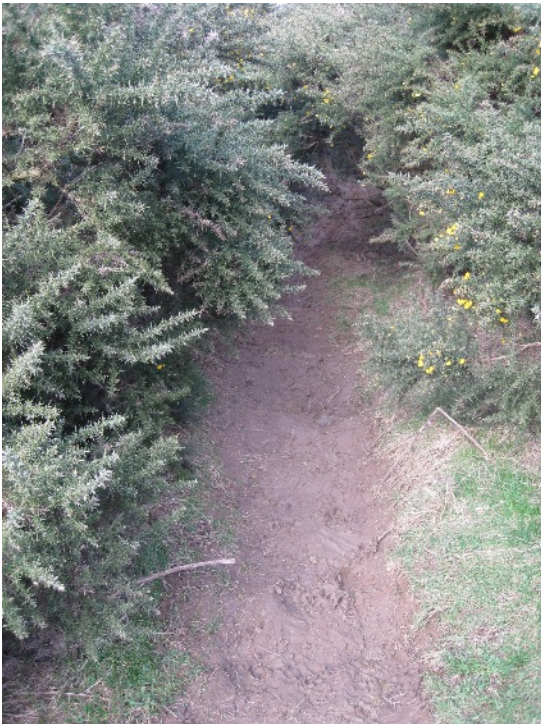
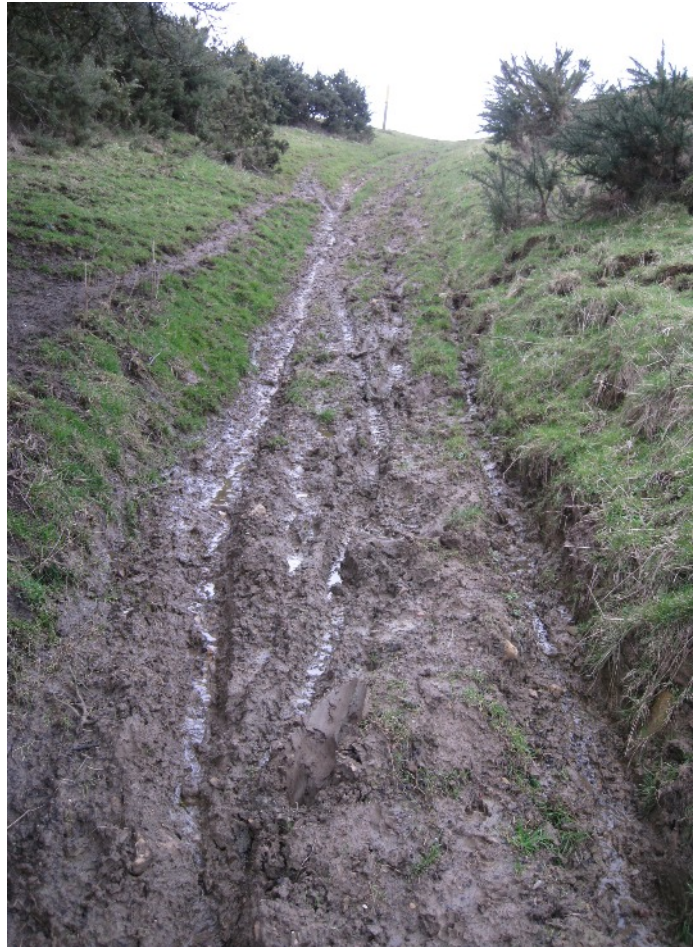
Some of the footpaths within the access area could do with some cutting back of the gorse which in places makes them unusable

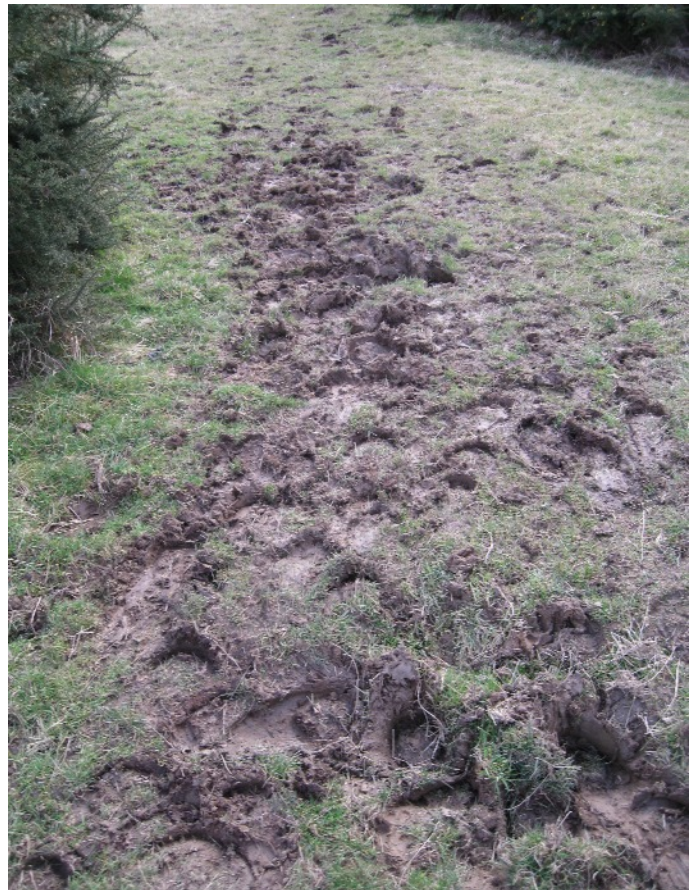
More evidence of the impact of horse traffic.

Consideration should be given to some form of segregation to allow horse riders to enjoy the area but leave walkers with a surface that is useable.
